Crystal Lake Watershed: Monitoring and Improvements by Public Works Dept.

Crystal Lake Conservancy Annual Meeting – October 25, 2012

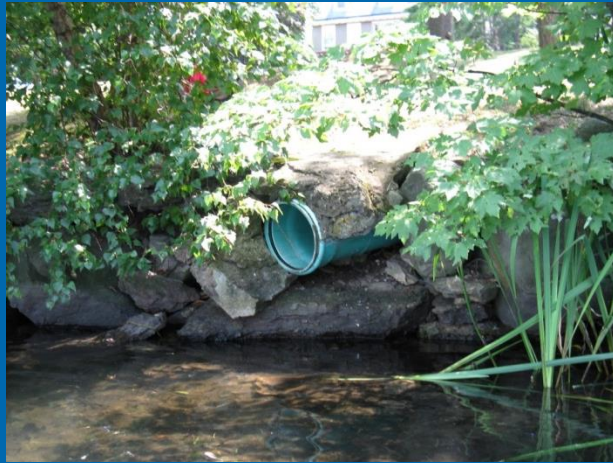
Outfall 4 – no longer in use

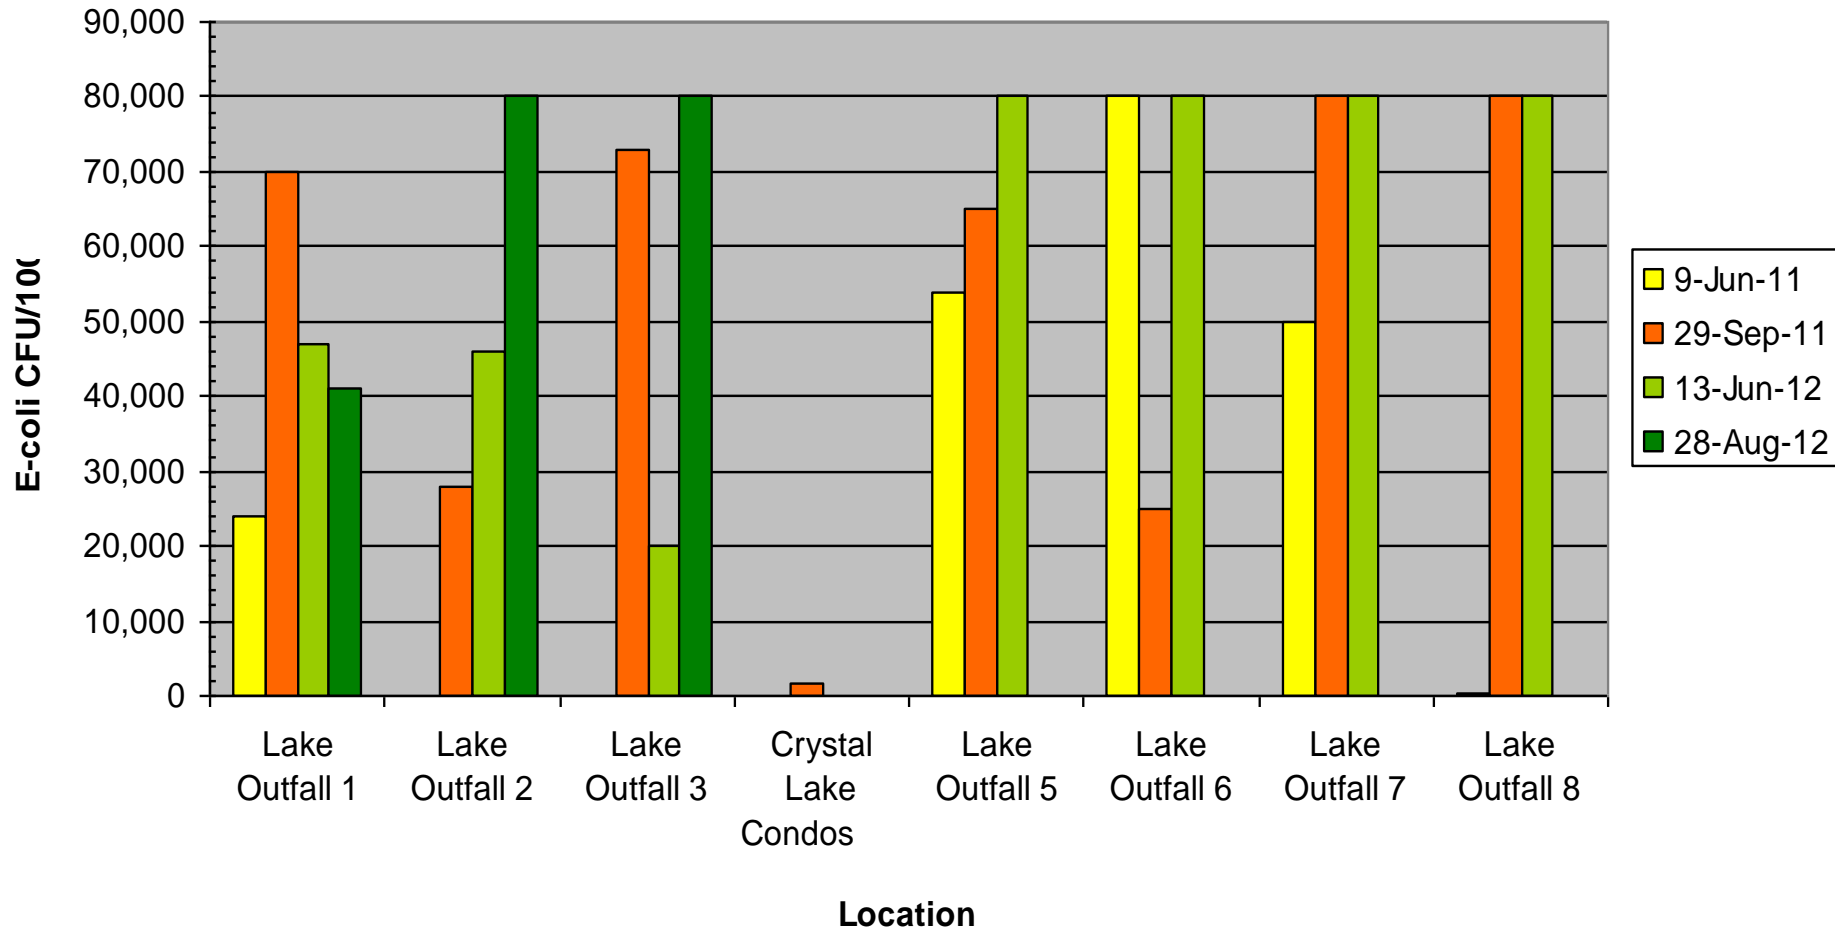
E-Coli Historical Data

For June 2011 event, the samples for Lake outfalls 2, 3, and 8 are lake samples collected next to the outfall. Crystal Lake condos samples are also lake samples behind the condo complex.

- E.Coli bacteria levels vary, but are consistently high at most outfall locations.
- Street runoff samples indicate that stormwater is contaminated before it enters the City's drainage system.
- Sewer cleaning, testing and sealing done in July 2011 did not improve results.
- More extensive sewer and drain cleaning of all pipes in watershed completed in February 2012 had little impact on the water quality.
- Phosphorus levels highest in the spring / summer.
- Detergents present in most samples above background levels.

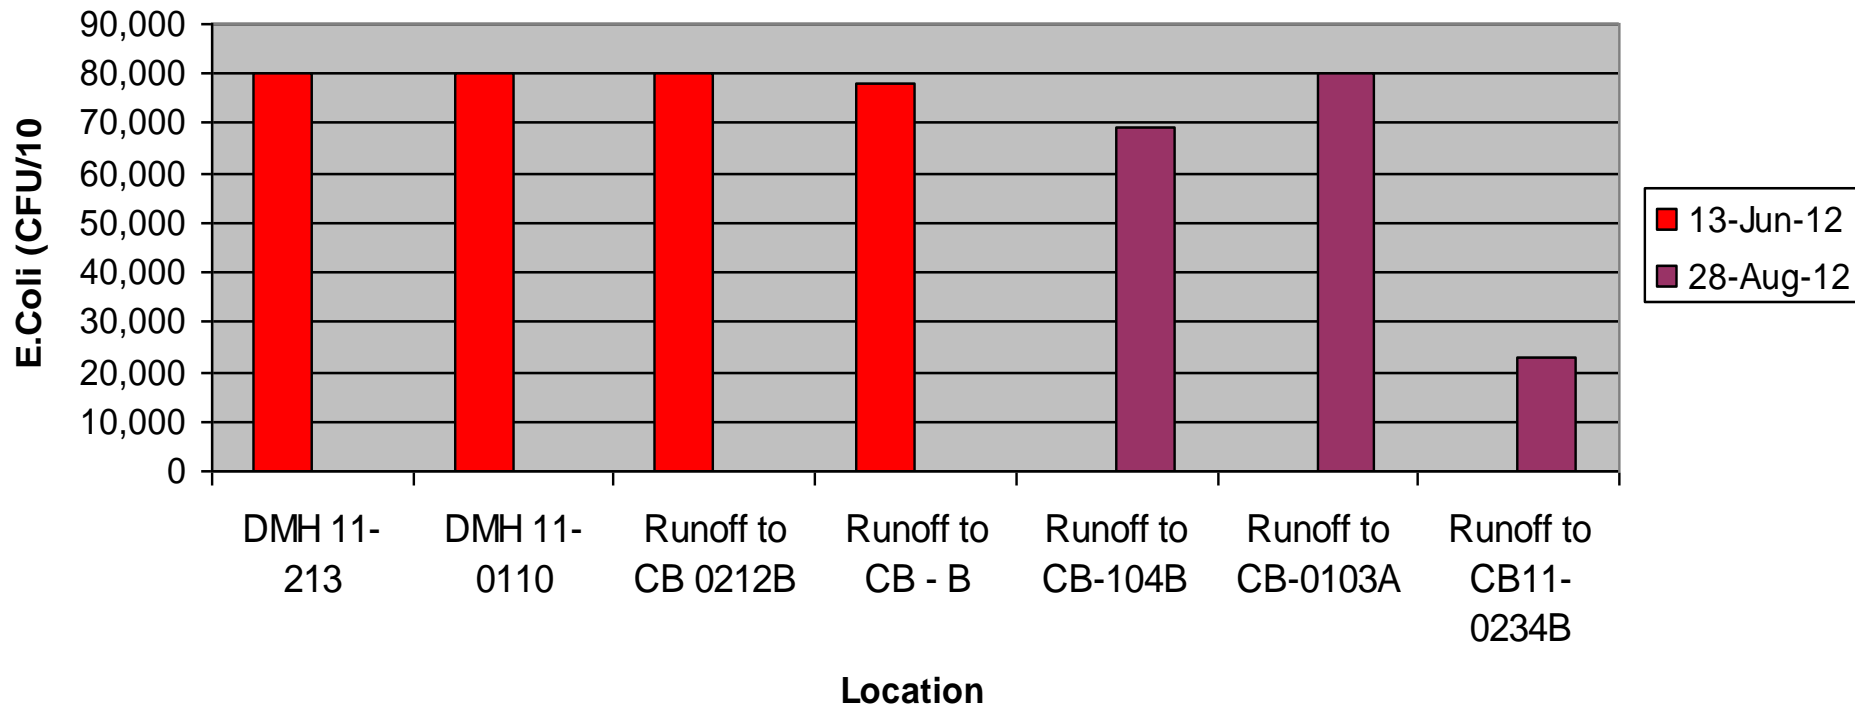
E-Coli Supplemental Data

- DMH11-213 → Outfall 5
- DMH11-0110 → Outfall 8
- CB 0212B → Outfall 5
- CB -B → Outfall 7
- CB 104B → Outfall 1
- CB 0103A → Outfall 2
- CB11-0234B → Outfall 3

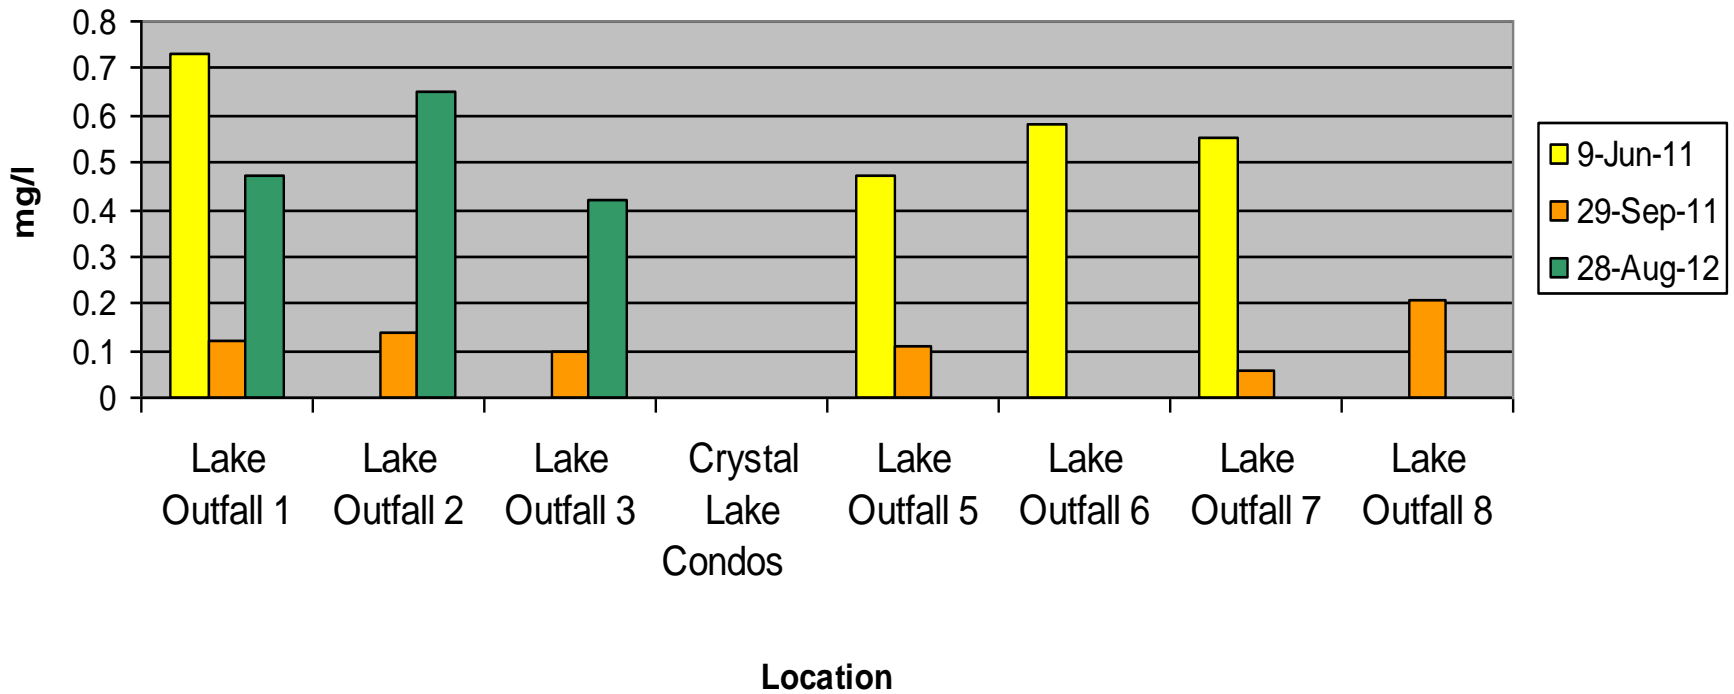
Total Phosphorus (mg/L)

For June 2011 event, the samples for Lake outfalls 2, 3, and 8 are lake samples collected next to the outfall. Crystal Lake condos samples are also lake samples behind the condo complex.
