Crystal Lake Conservancy Second Annual Forum

October 24, 2011

BEALS · ASSOCIATES

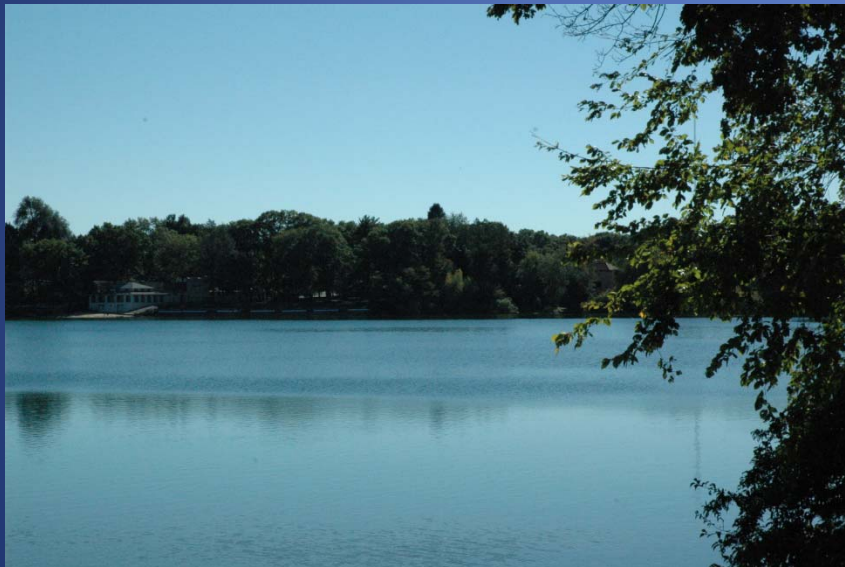
Crystal Lake Statistics

- 33 acres (13 ha)
- Classified as a Great Pond
- Drains into the Charles River
- Shoreline is about one mile
- Length is 1,200 ft (N/S)
- Width is 1,000 ft (E/W)
- Greatest Depth is about 31 ft

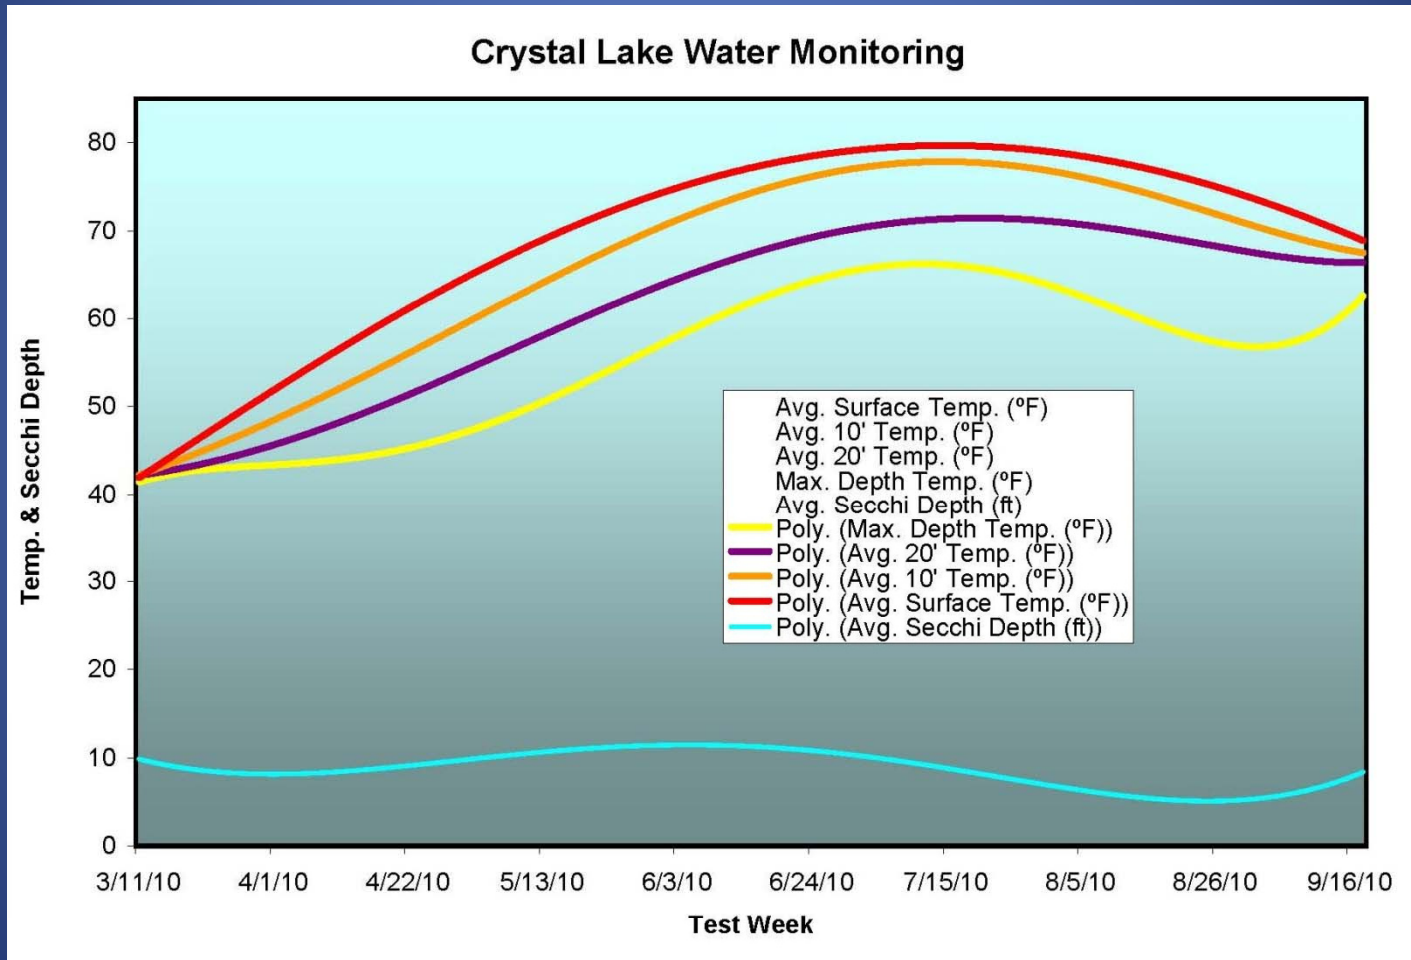
2010 Temperature and Secchi Disk versus Time

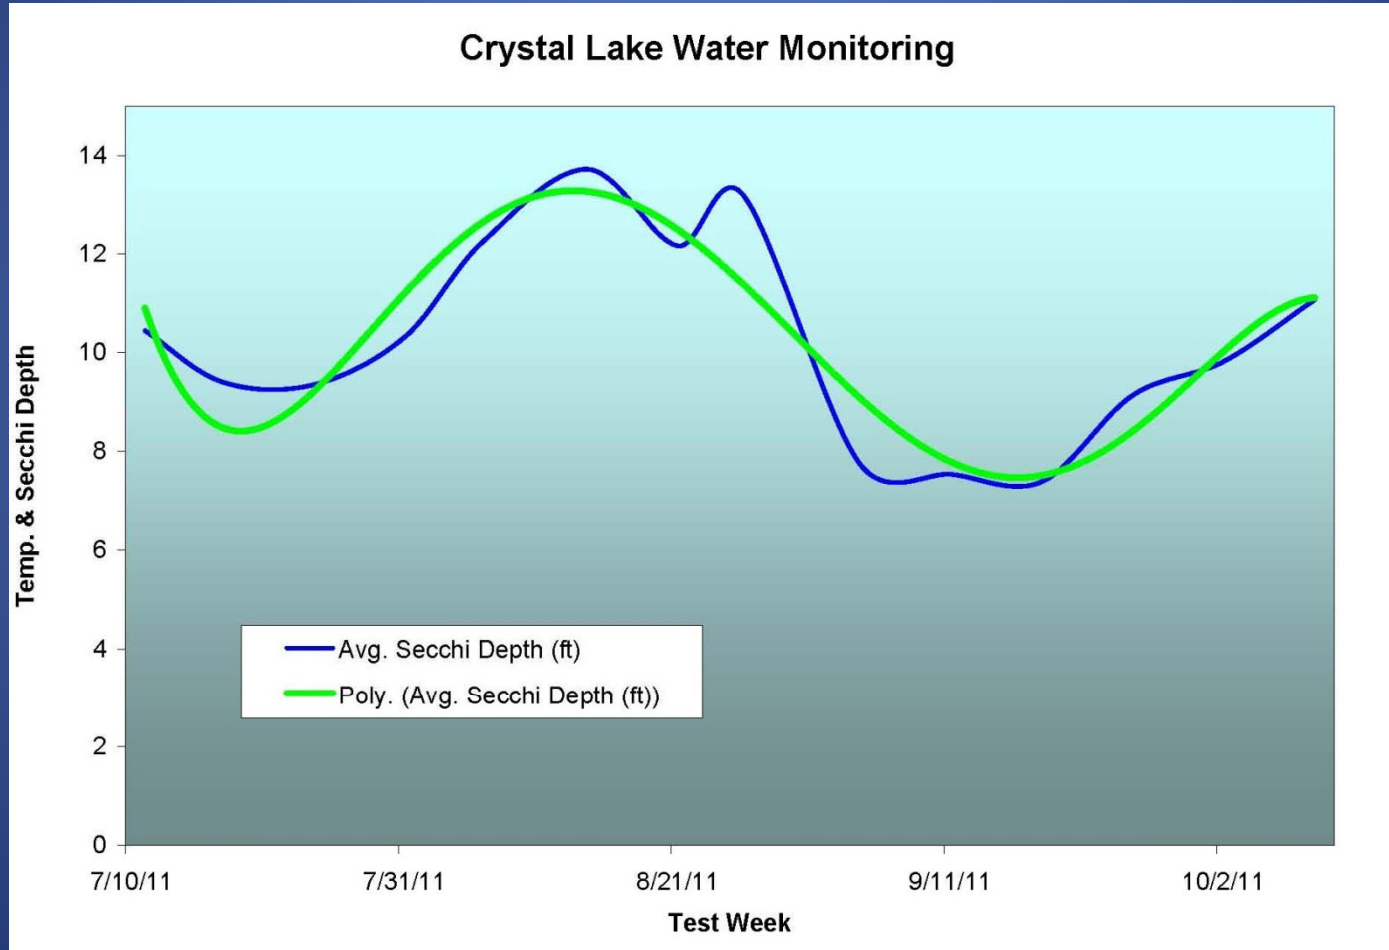
Secchi Disk Visibility 2011

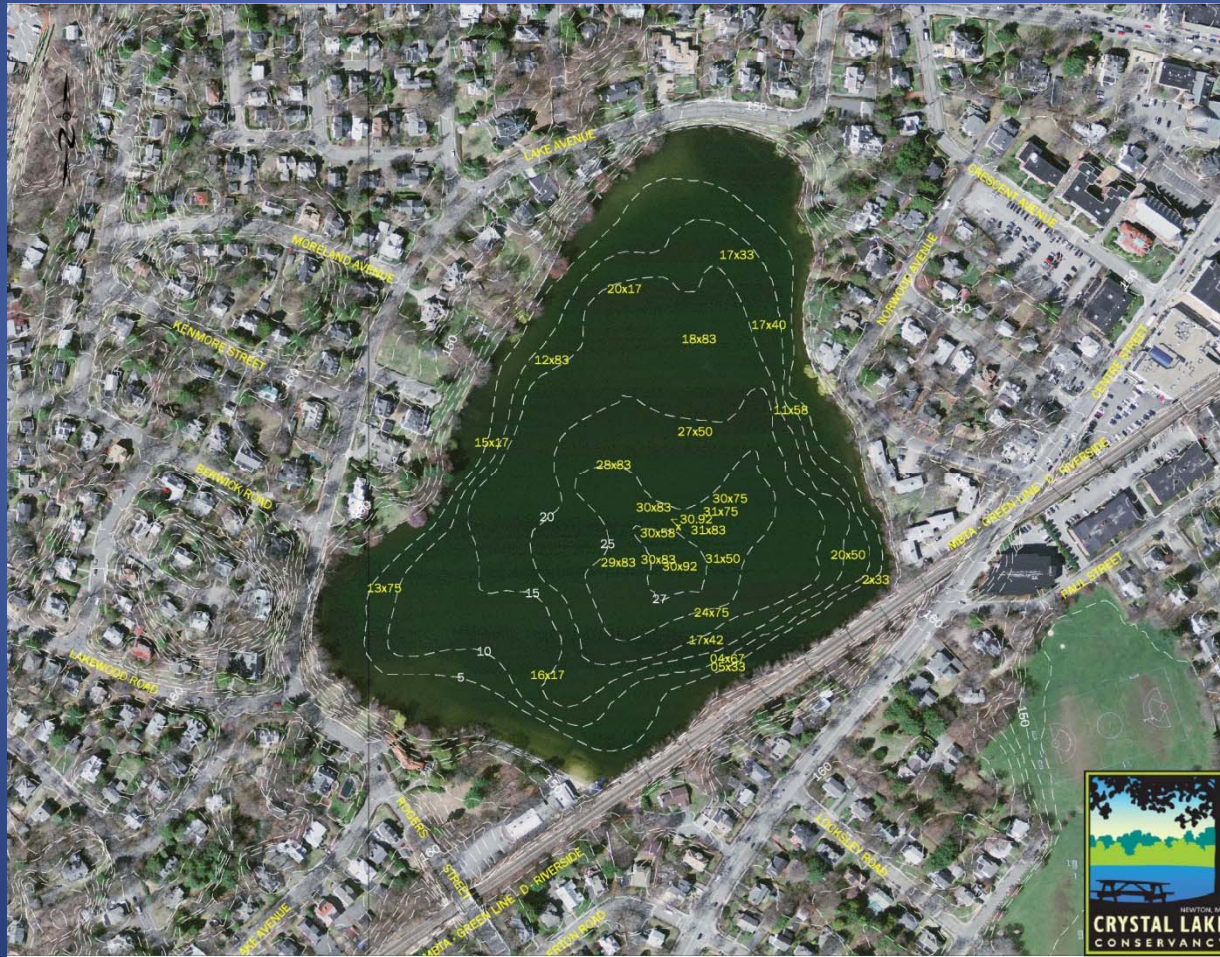
Crystal Lake Bathymetry

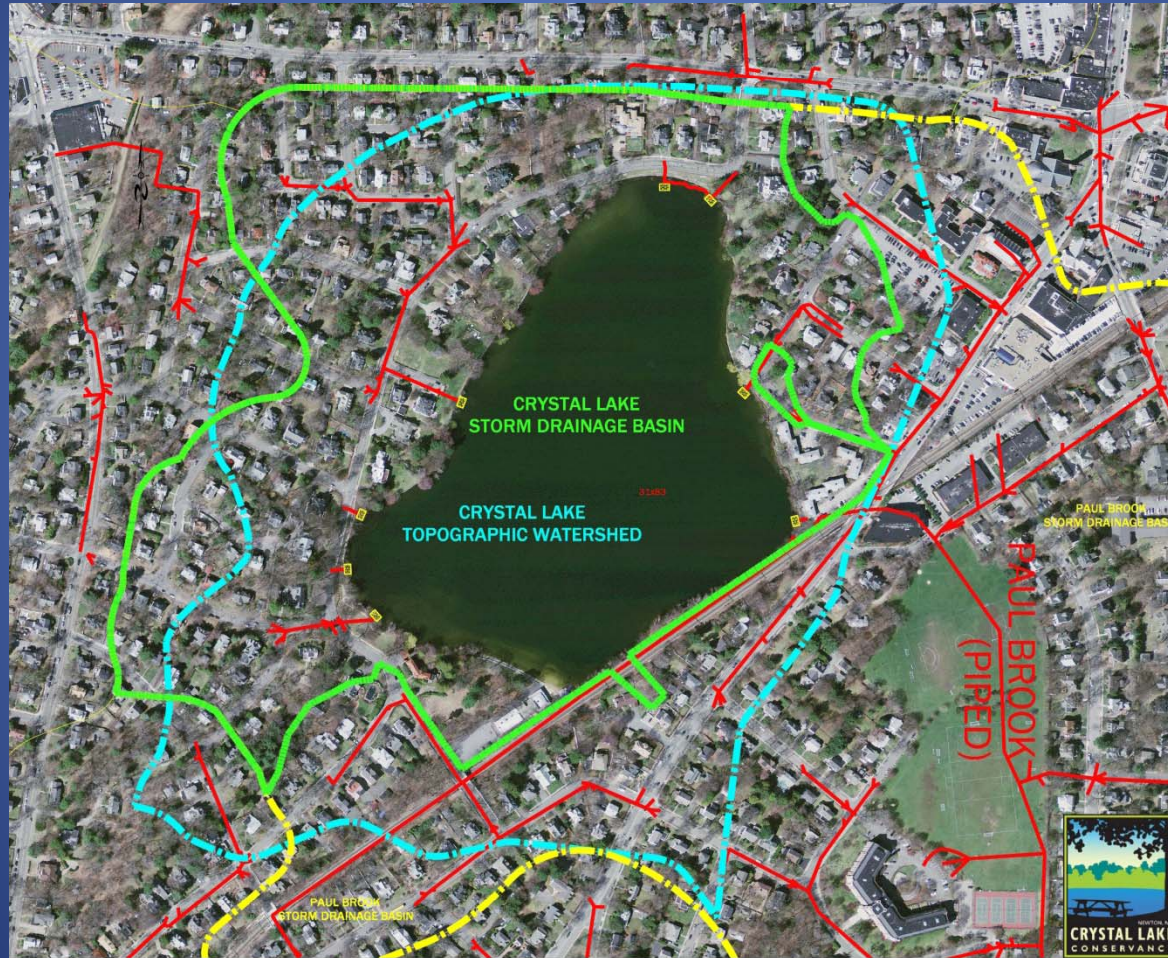
The Crystal Lake Watershed

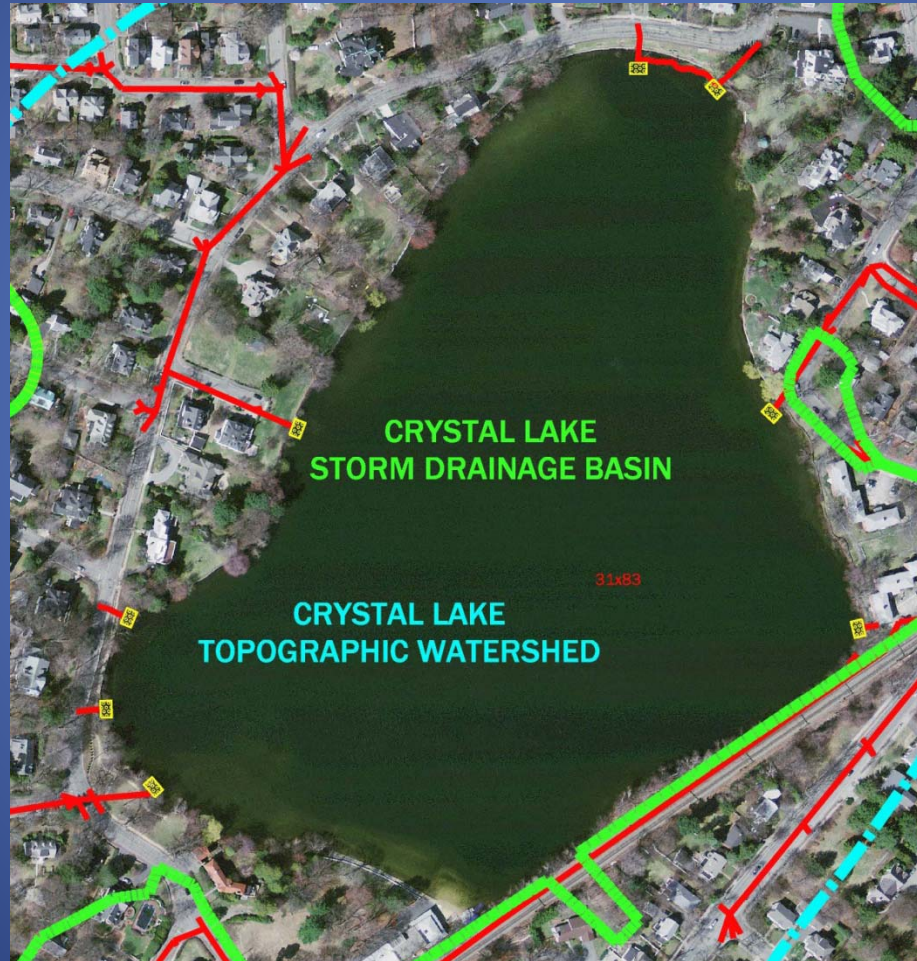
Storm Water Discharge Point into Crystal Lake

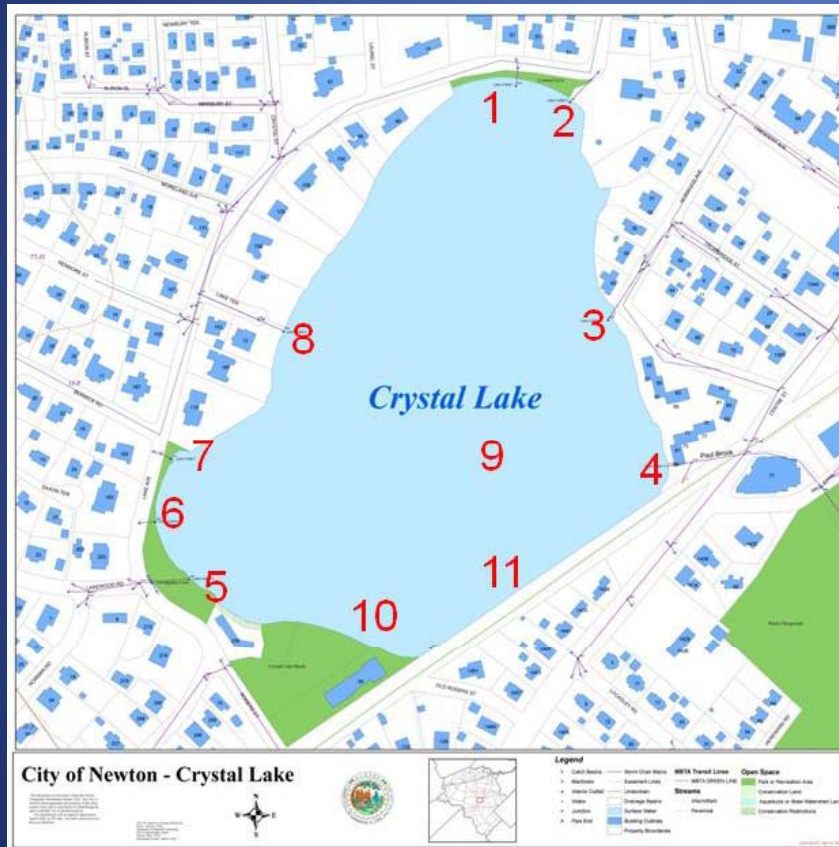
Nitrate, Nitrite and Ammonia Test Results Early August, 2011

- A trace of Nitrate was detected at Outfall 3
- Nitrate, Nitrite, and Ammonia were not detected at any other location in the lake
